Emergency Watershed Protection Assessment  
Simi and Verdale Incidents  
November 10, 2003

# **Simi & Verdale Incidents**

## **Emergency Watershed Protection Assessment**

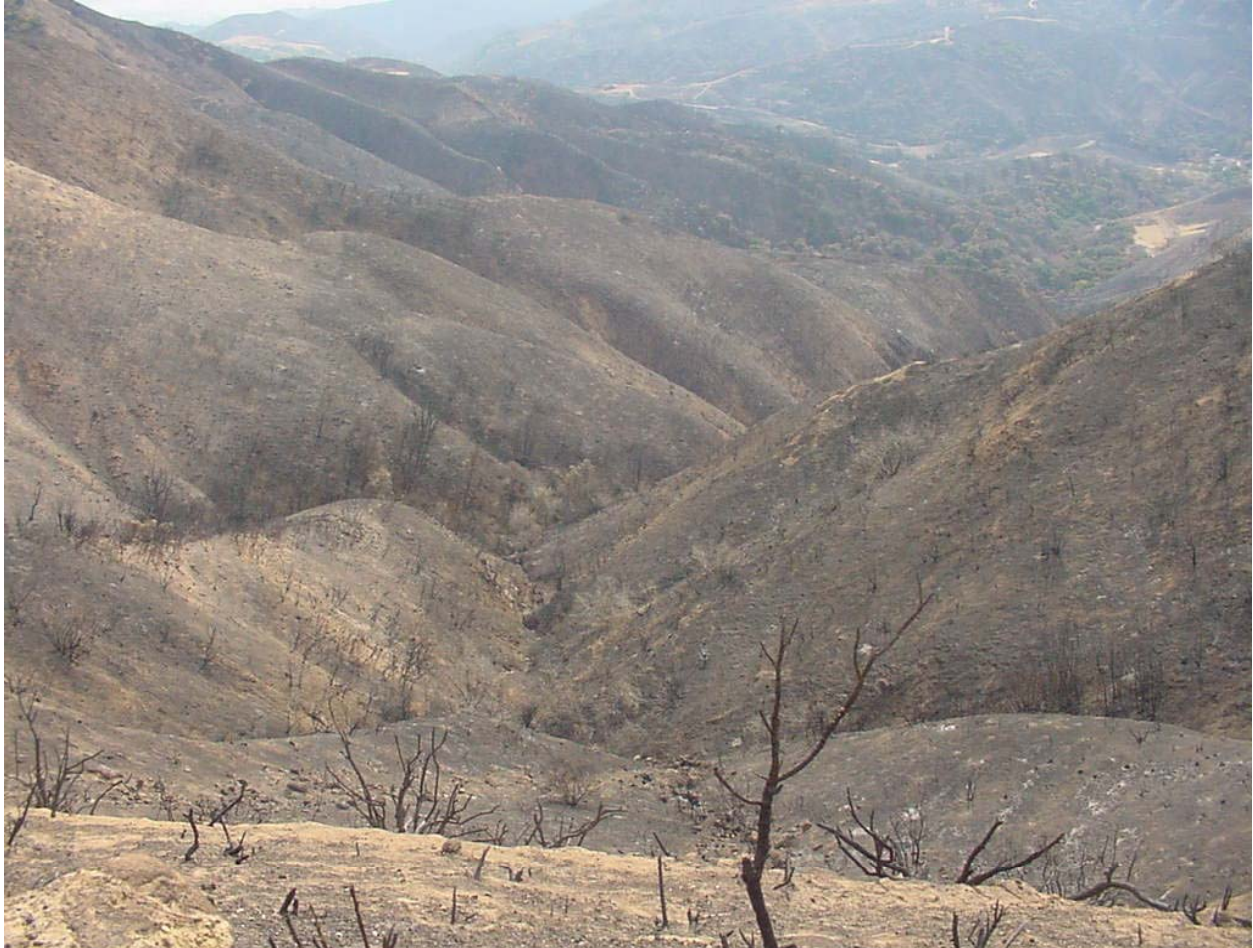
View looking west/southwest down into Sulphur Canyon. High Severity  
Burn-Drains into Las Lajas Canyon

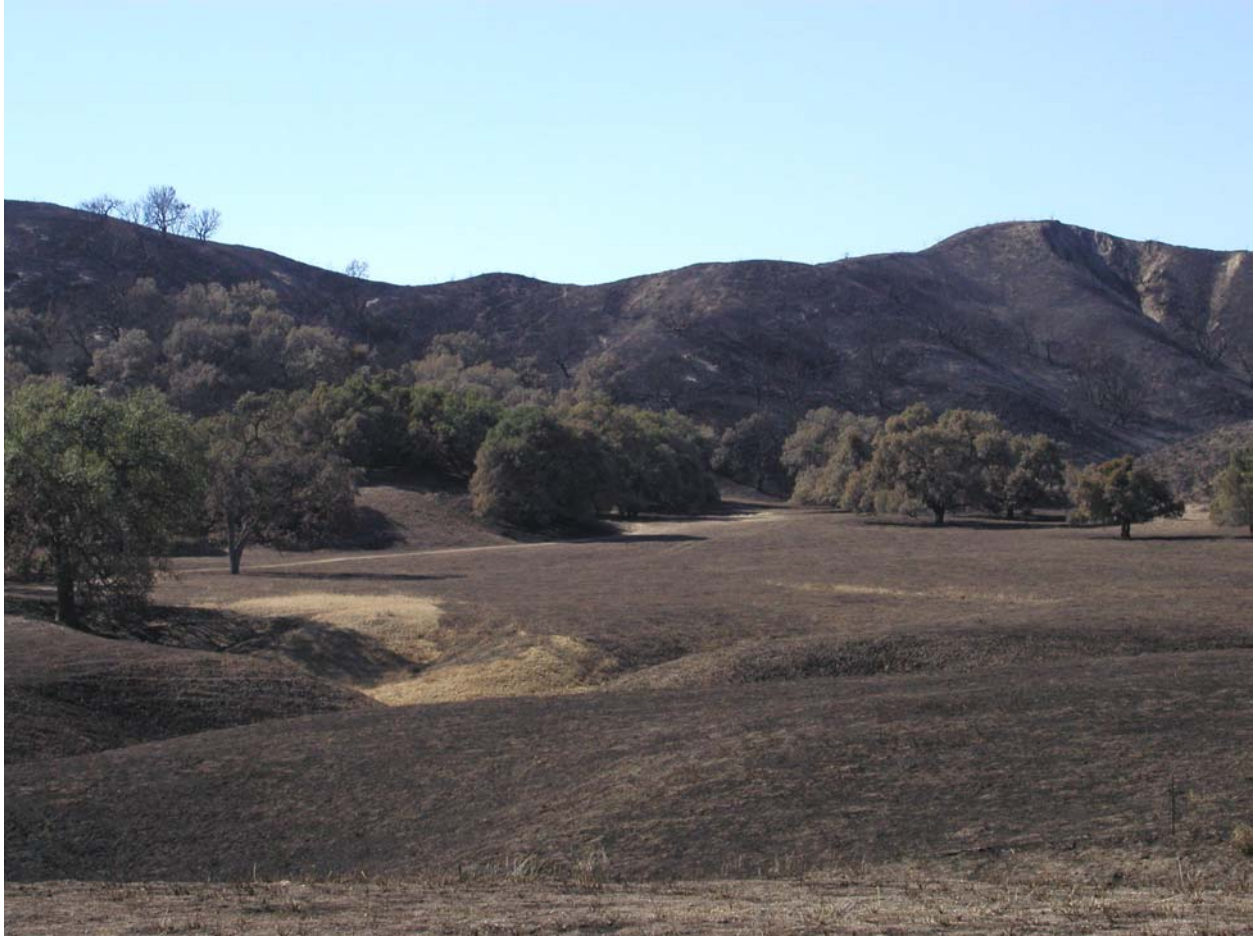
Tapo Canyon—Light Burn Severity

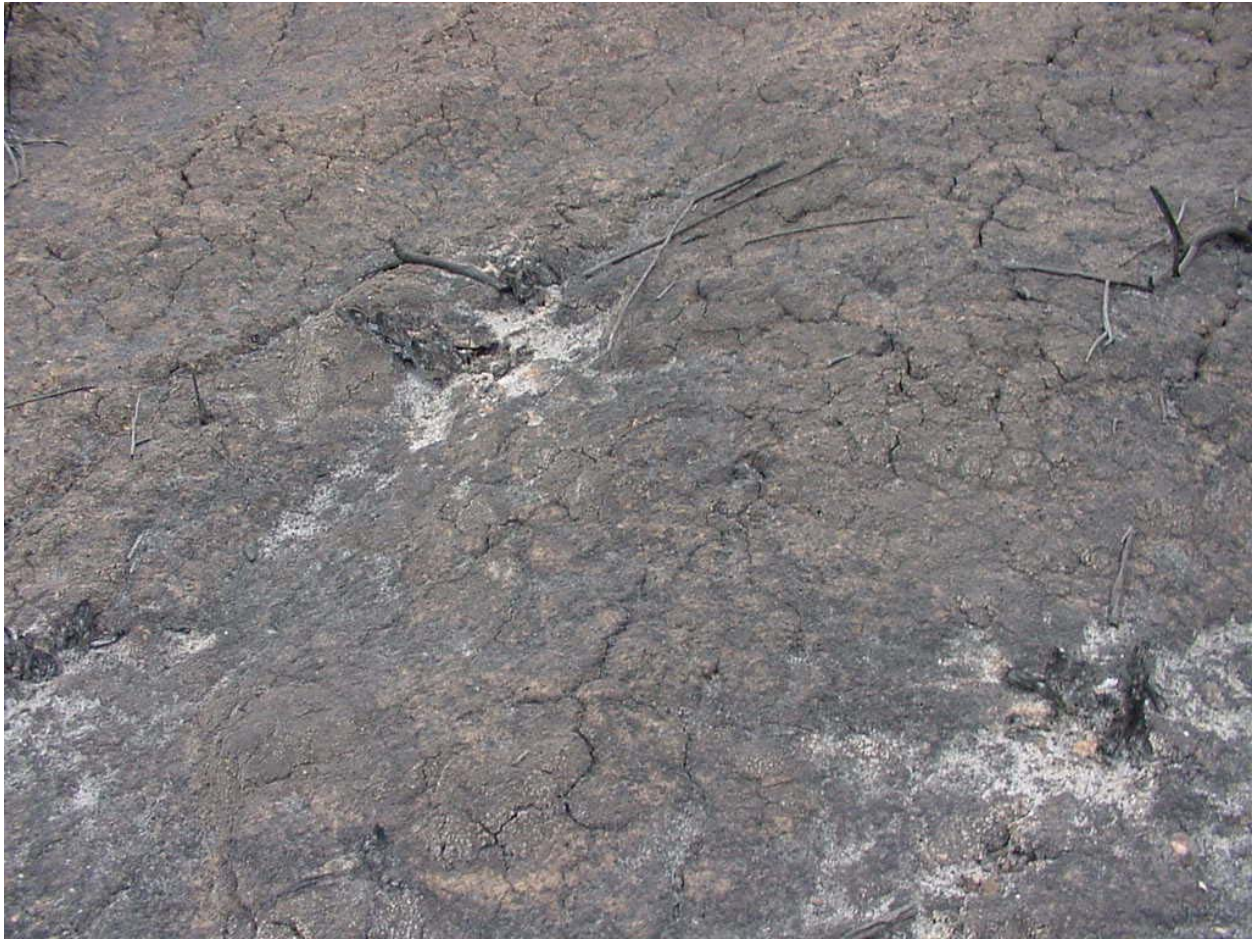
Cracked Soils in Pico Canyon

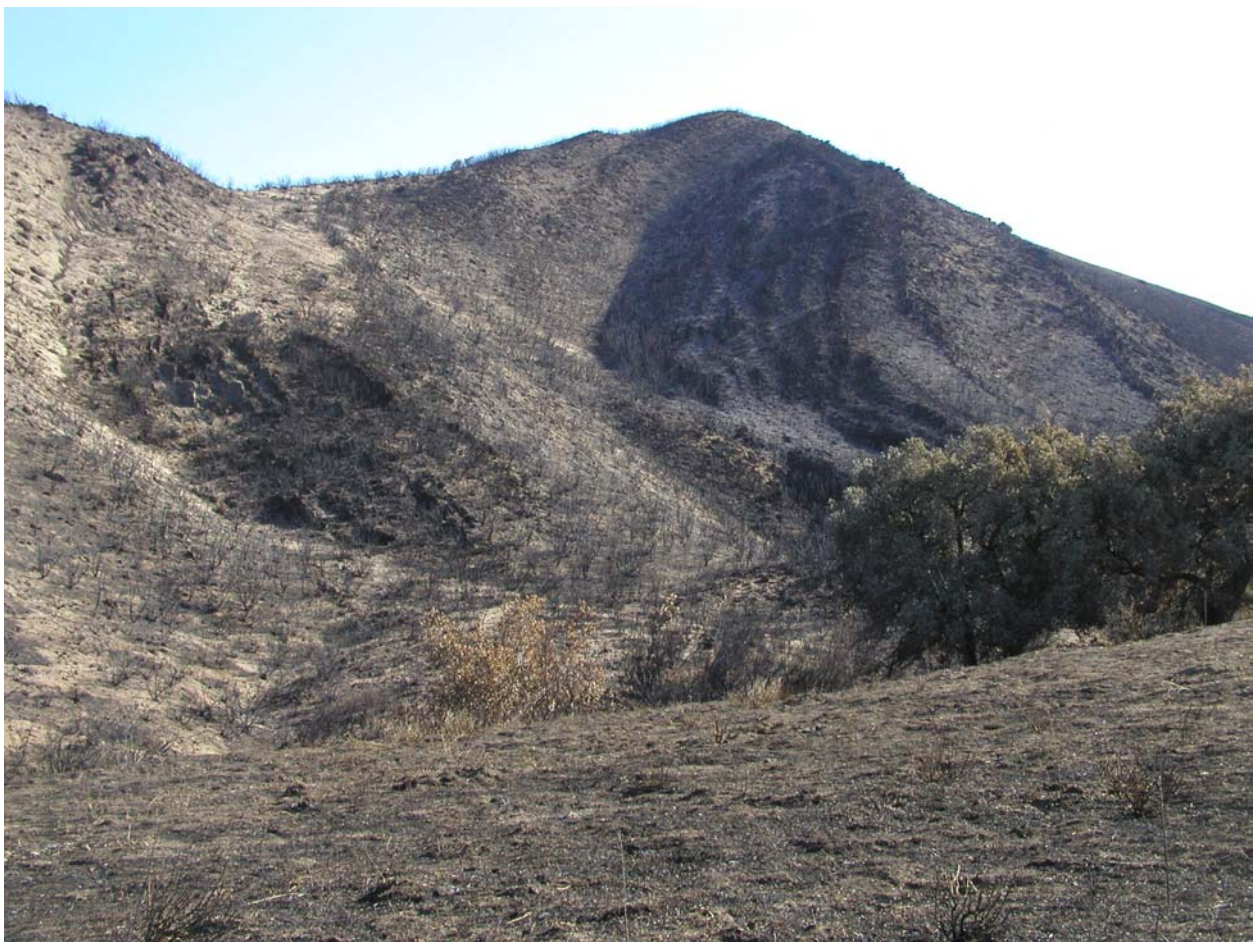
Tapo Ranch Moderate Burn Severity.

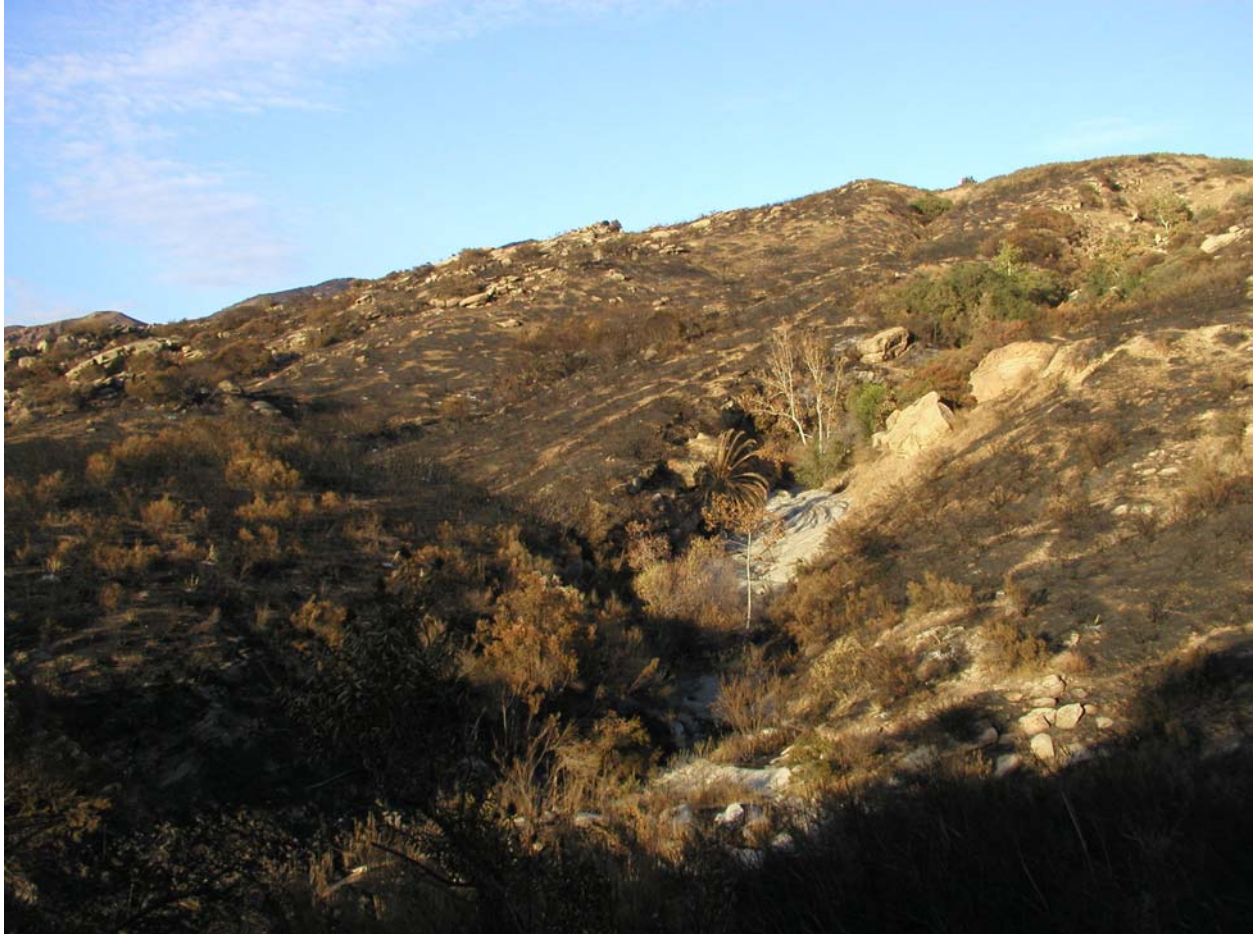
White Oak Drainage- Moderate to Low Burn Severity.

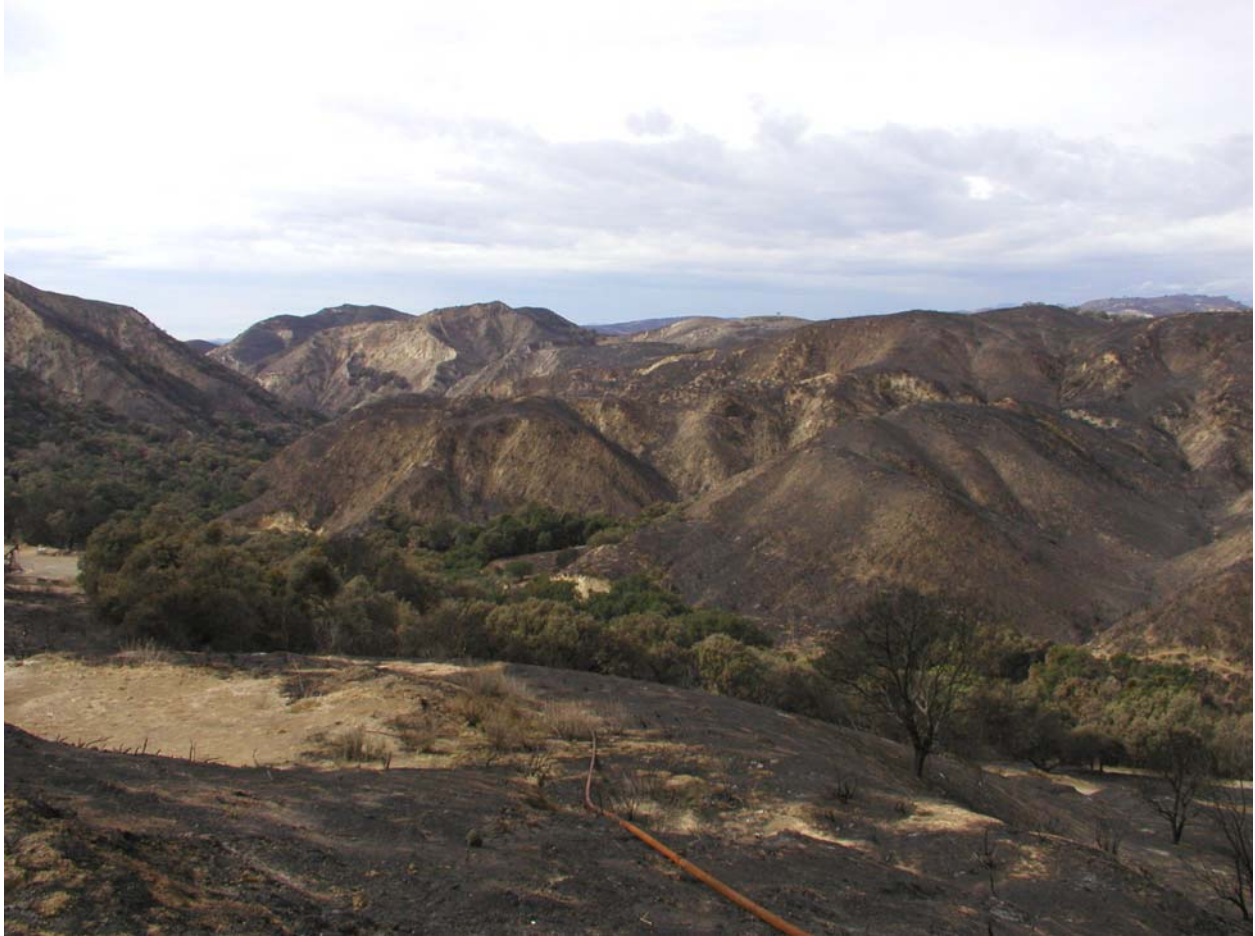
Las Lajas looking Southwest, Mid Canyon.

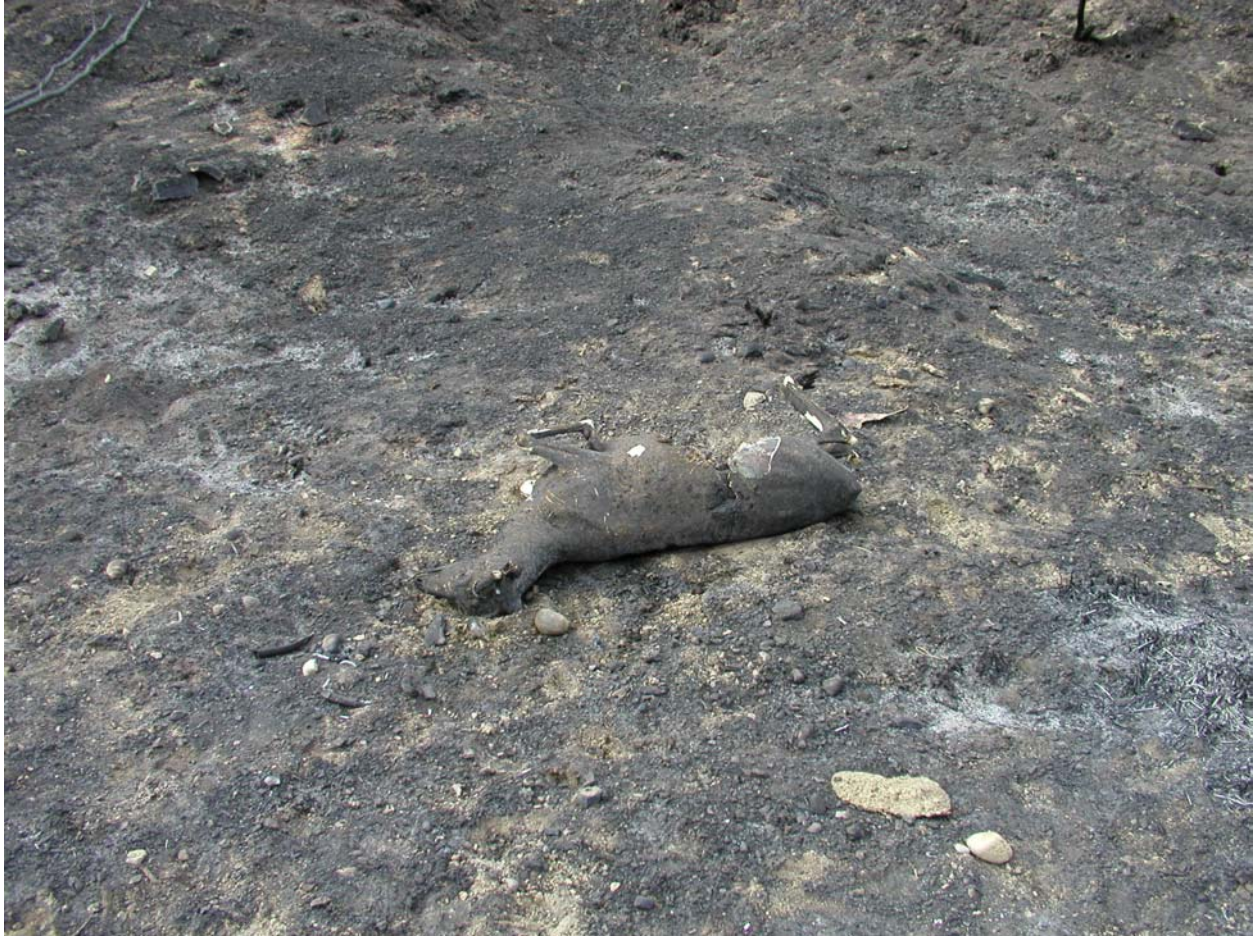
High Burn Severity

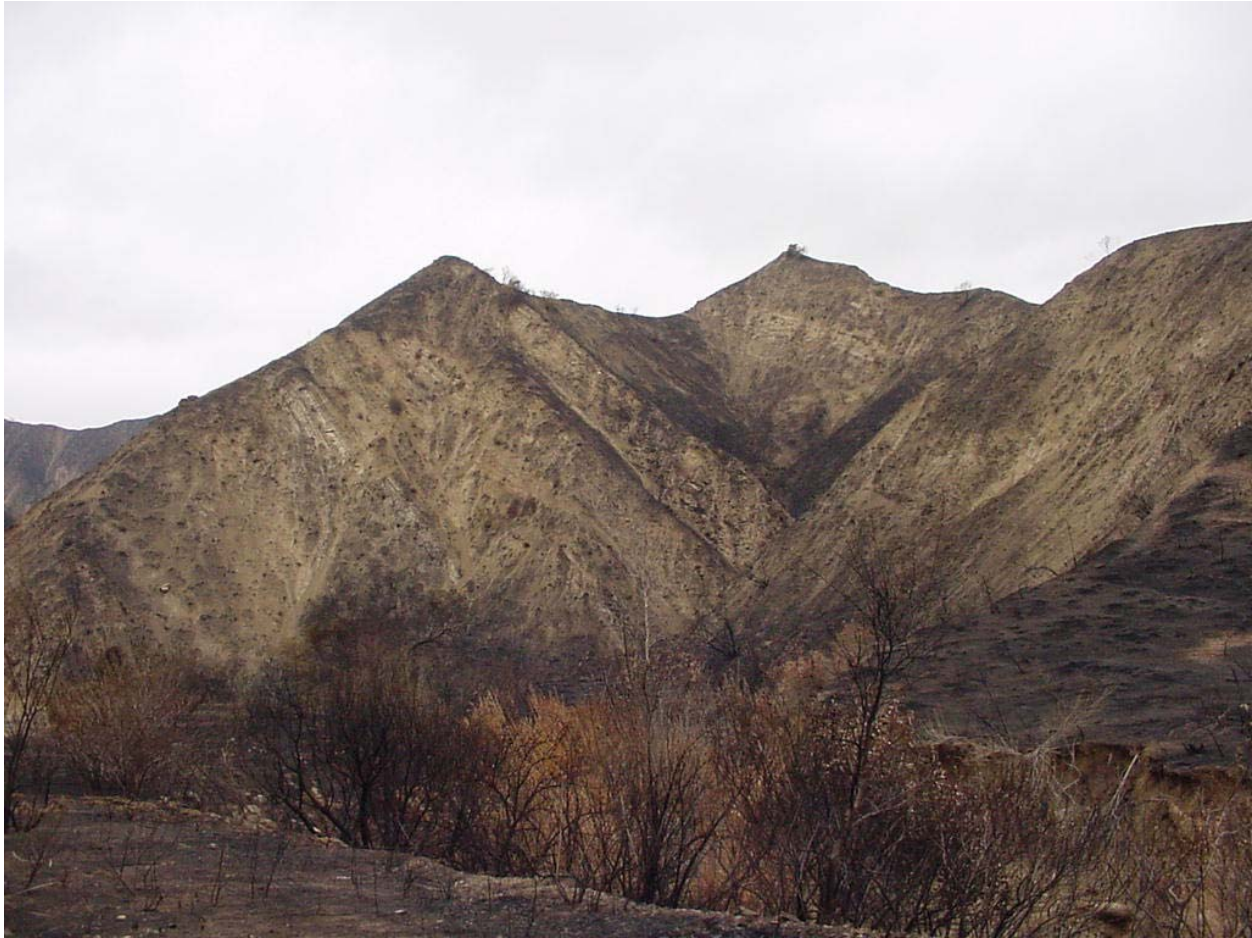
Towsley Canyon Raveling Soil.

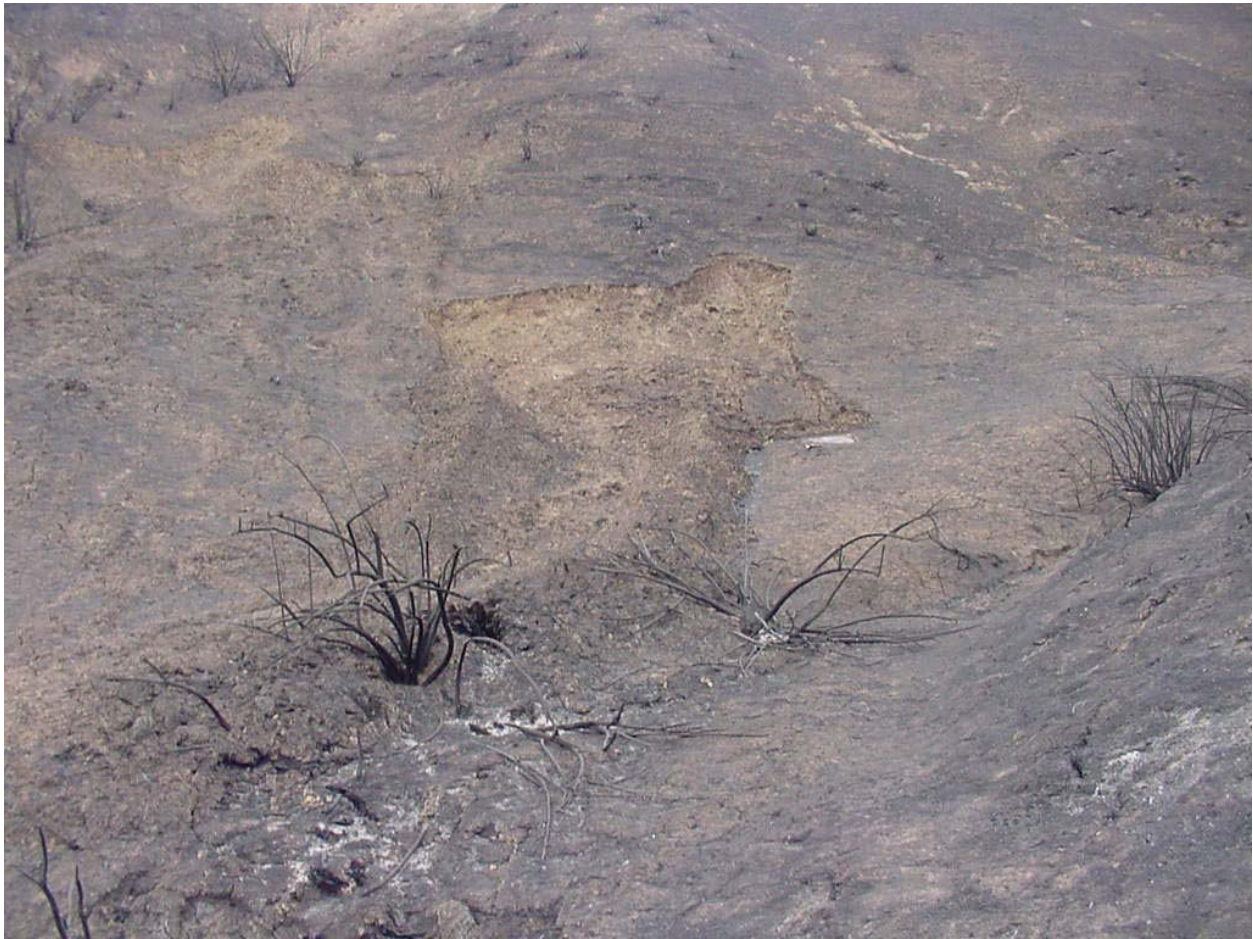
Pico Canyon Slope Failure. Failure measures approximately 15' X 10'
